TAHOE PARK NEIGHBORHOOD ASSOCIATION WALK AUDIT REPORT

A Report by WALKSacramento

2015

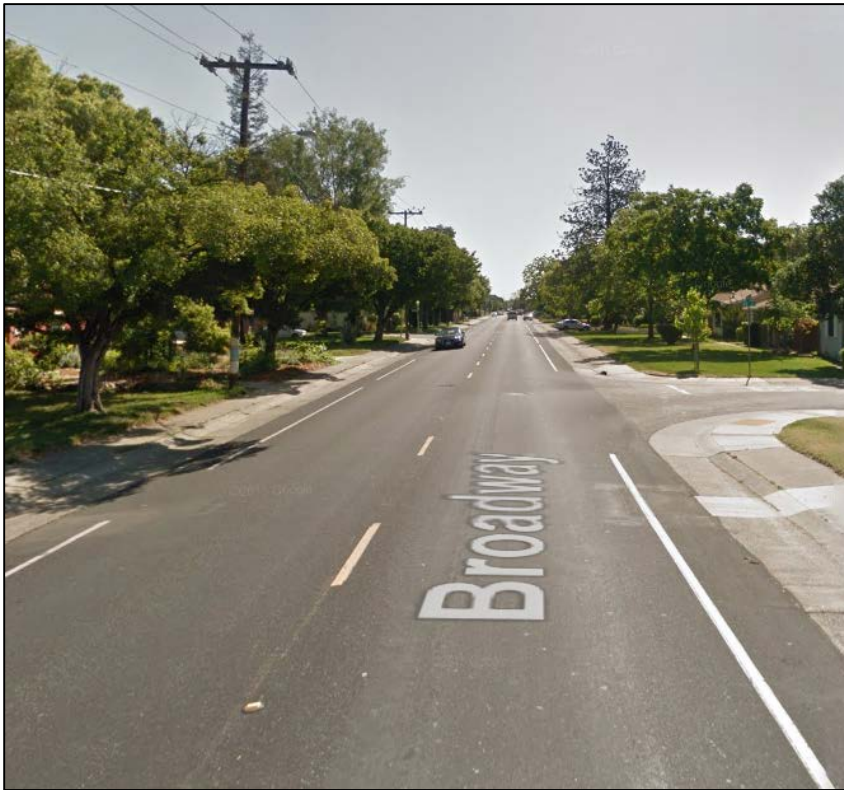
The Broadway corridor between 57th Street and 65th Street is a two lane roadway with 12 ft. vehicle lanes and approximately 7.5 ft. striped shoulders. The bicycle master plan identifies class II bike lanes on Broadway between Stockton Boulevard and 61st Street. Past 61st Street the striped shoulders are designated as vehicle parking lanes. The pedestrian environment along this stretch of Broadway include five-foot sidewalks with rolled curbs. The rolled curbs sometimes lead to parked cars mounting the sidewalk and thus narrowing the pedestrian right of way. Drive lane width is relatively consistent along this corridor except at two intersections (59th Street and 65th Street) where the eastbound lanes narrow to accommodate a left turn lane. At those same locations, back-out parking creates barriers to unimpeded pedestrian travel.

There are no 4-way intersections along this entire stretch of roadway except at 65th Street. This means that all north and southbound traffic must also travel laterally on Broadway for a short distance. This leads to more traffic on Broadway than at similar four-way intersections. Across Broadway there are no midblock crossings and only four marked crossings. Along the 3/5 of a mile long corridor, only five of the sixteen intersections contain a marked crosswalk. Furthermore, only 16% of the total intersection legs are marked.

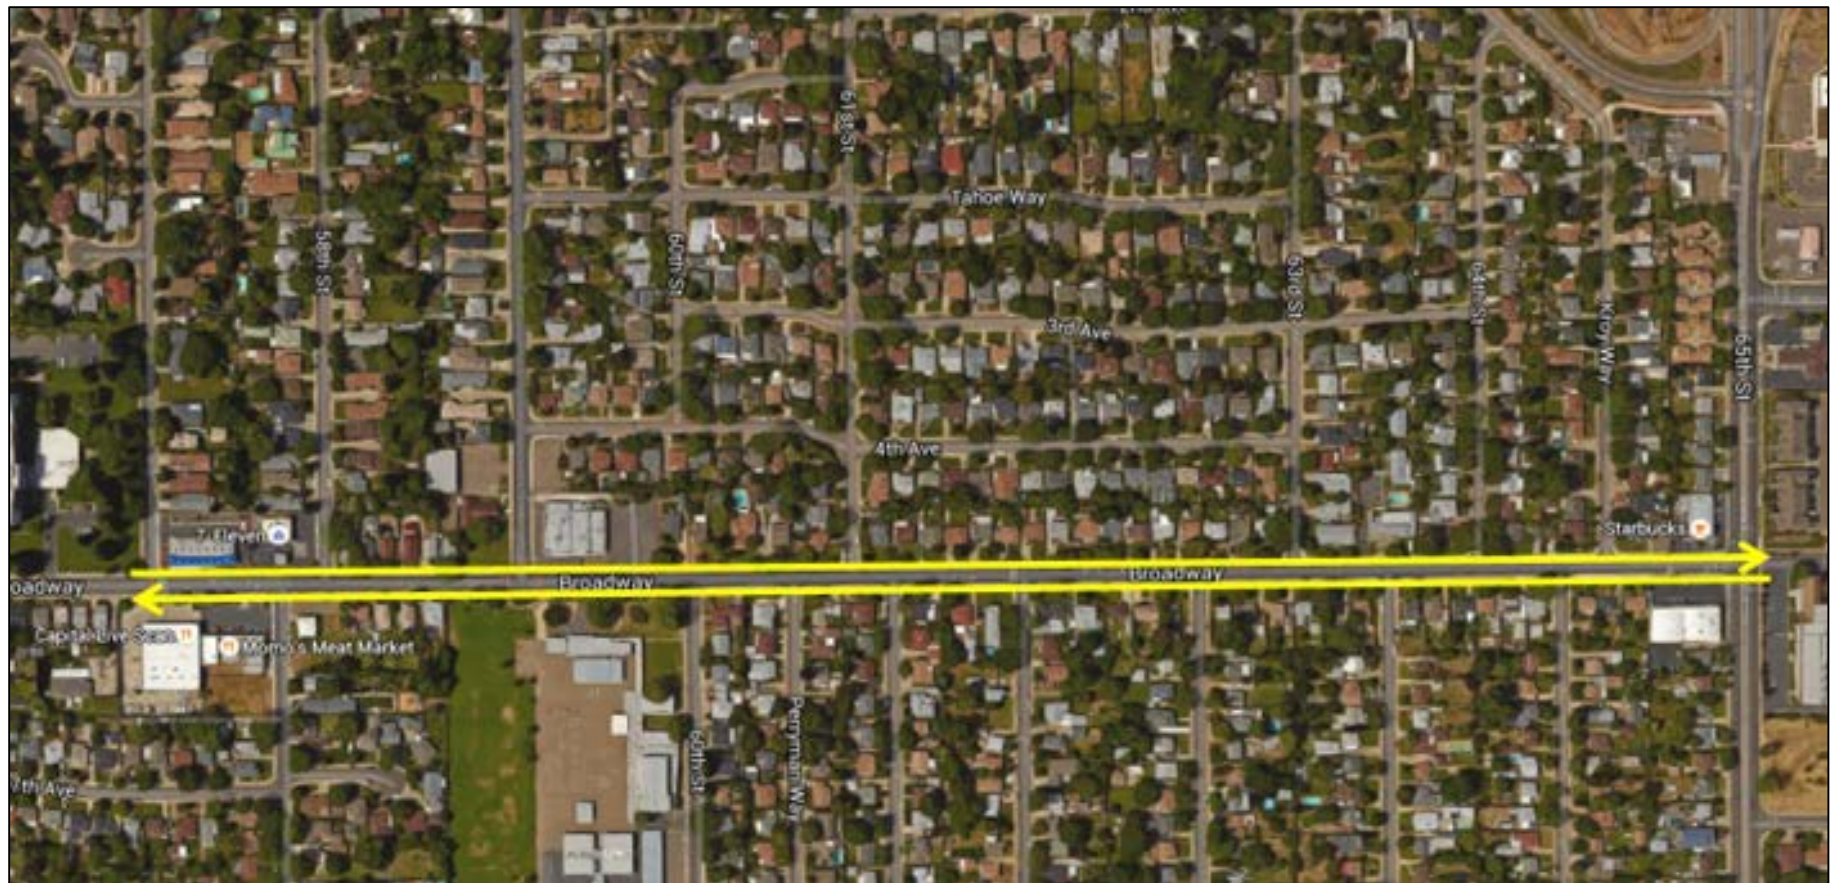
Walk Audit Map

The audit covered both the north and south sides of Broadway between 57th Street and 65th Street. Participants made particular note of the walking and biking environment, assessing pedestrian and bicycle facilities, the prevalence of crossing opportunities, driver behavior, and other factors that may create barriers to alternative forms of transportation.

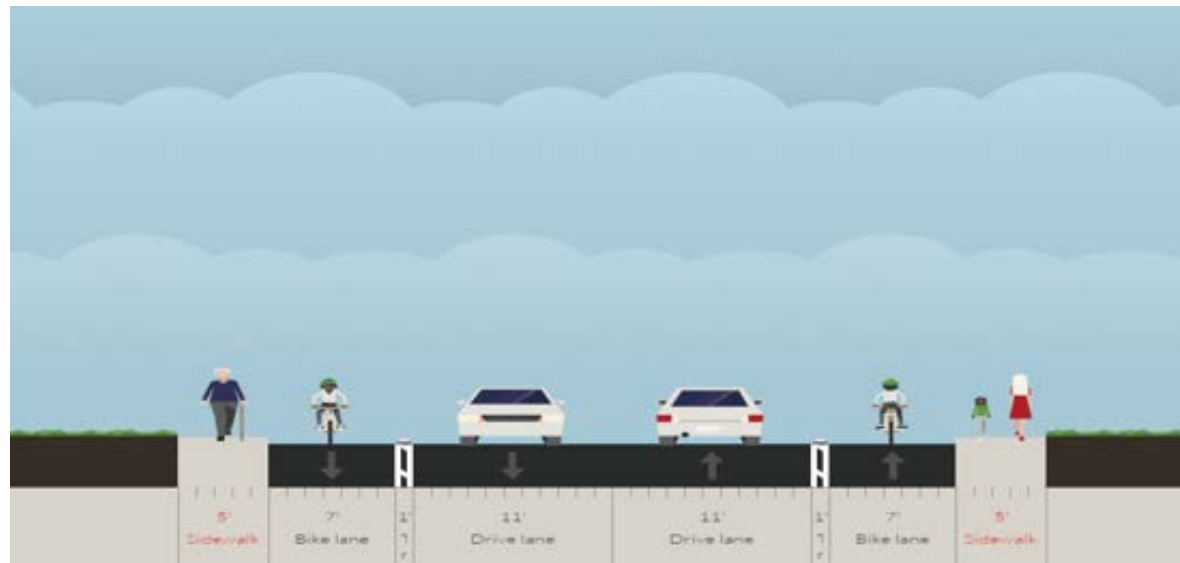
Visual

ID	Location	Recommendation	Justification
1	Broadway between 57 th Street and 65 th Street	Implement a Complete Streets, traffic calming retrofit within the existing right-of-way.	<ul style="list-style-type: none"> The lowest allowable standard for drive lanes in the City of Sacramento are 11 ft. wide. Narrow lanes have proven effective at calming traffic speeds.ⁱⁱ The 2 ft. gained by narrowing the lanes make available room for 1 ft. buffers on both sides of the street. To make the striped shoulders useable as bike lanes, on-street parking must be restricted. According the City's street standards, parking is restricted on arterials that are in excess of 14,000 ADT (Average Daily Trips). According to the 65th Street Station Area Plan, a traffic analysis in 2010, and traffic counts along Broadway, ADT has been projected near 14,000. As development continues to occur in this area, it is possible that this number will soon exceed 14,000. The striped buffers, preferably inlaid with tactile bumps to alert drivers, will not only provide separation for cyclists, but will help deter drivers from circumventing left-turning traffic through the bike lanes or on sidewalks.ⁱⁱⁱ This Complete Streets conversion conforms to roadway design standards, requires no additional procurement of right of way, proposes no major infrastructure installation, and can be accomplished relatively cheaply if coordinated with resurfacing efforts. While eliminating parking may be a tough sell for nearby homeowners, based on an aerial analysis, nearly all properties along this stretch can easily accommodate at least two cars with garages and/or long driveways. Additional on street parking can be accommodated on the numerical north/south streets.

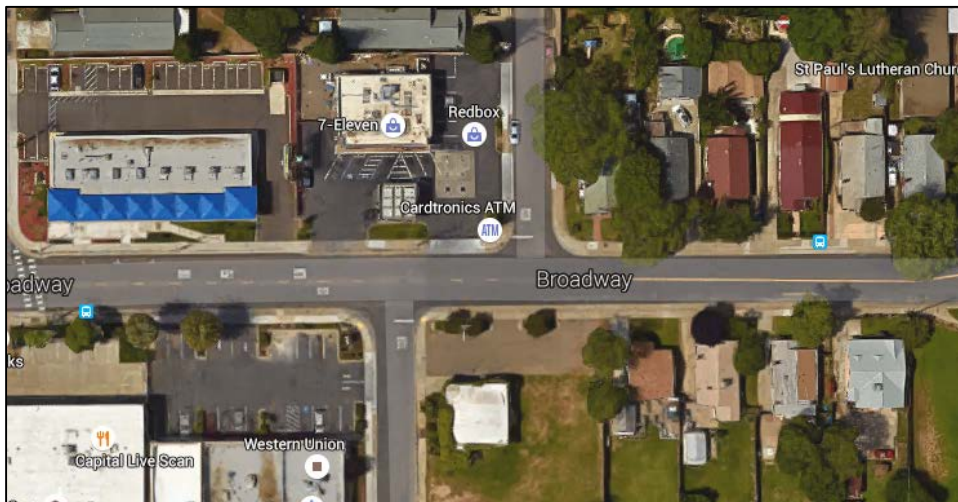
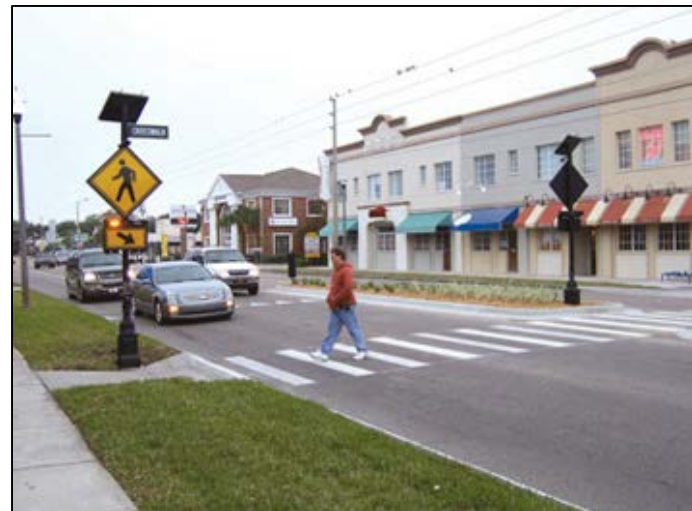
Visual

ID	Location	Recommendation	Justification
2	58 th Street and Broadway	Install a rapid rectangular flashing beacon (RRFB) crosswalk across Broadway at 58 th Street.	<p>58th Street is a major north-south connector street through the Tahoe Park Neighborhood for vehicles, pedestrians, and bicyclists. Due to the misalignment of 58th at Broadway, all north-south trips must travel for a distance on Broadway. Due to the lack of a dedicated turn lane, motorist continuing on 58th either wait for a break in both direction of traffic to make a rapid two-stage turn, or cause traffic to back-up as they wait to turn left. Adding to this situation are two driveways at the corner gas station that add additional vehicles onto Broadway. This combination of issues has led to vehicles failing to yield for pedestrians crossing Broadway and near-collisions as motorists try to navigate the intersection.</p> <p>To increase the rate of yielding at this intersection and to improve visibility of pedestrians, an RRFB should be installed. According to the Federal Highway Administration, RRFBs can enhance safety by reducing crashes between vehicles and pedestrians. RRFBs are a lower cost alternative to traffic signals and hybrid signals that are shown to increase driver yielding behavior at crosswalks significantly when compared to standard pedestrian crossing markings. At the intersection of Broadway and 58th there are no marked crossings or signs. The cost of an RRFB is approximately \$10,000 to \$15,000 for purchase and installation of two units with solar panels for powering the units.^{iv}</p> <p>According to City of Sacramento traffic engineers, the City typically no longer approves smaller parcels with four driveways. Thus, an opportunity exists to negotiate with either the existing or future tenant to close the eastern most driveway on Broadway to make room for a crosswalk. This is particularly relevant should the landowner attempt to redevelop the site at any point in the future.</p>

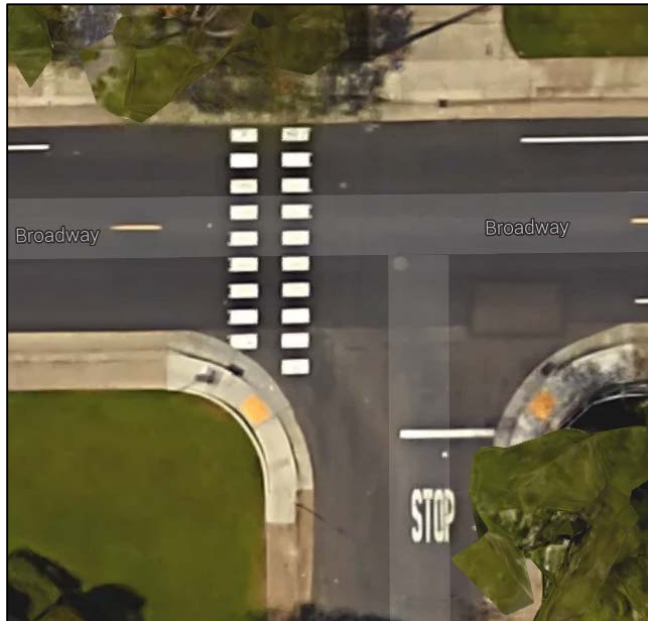
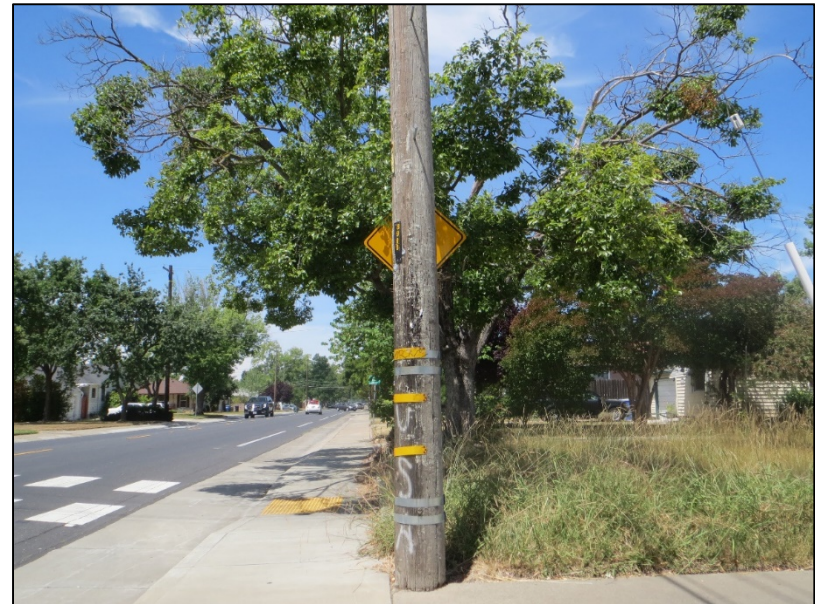
Visual

ID	Location	Recommendation	Justification
3	62 nd Street and Broadway	<p>Upgrade this crossing to an RRFB crossing</p> <p>Relocate the pedestrian crossing sign to be more visible to motorists</p>	<p>Between 65th Street and this crosswalk at 62nd Street (a distance of 1,445 ft.) there are no marked pedestrian crossings nor any traffic controls. From a driver yield survey at this intersection, only 18 of 100 (18%) of drivers yielded for a pedestrian. A combination of high speeds, a fear that because of higher speeds a driver may be rear-ended if they yield, and poor visibility of pedestrians may be contributing to this lack of compliance.</p> <p>As stated above, flashing beacon crosswalks have been proven to increase driver yield rates at crosswalks when compared to traditionally marked crosswalks. Additionally, the enhanced crossing may induce motorists to slow as they enter the more pedestrian focused area of Broadway between 61st and 57th Streets.</p> <p>The pedestrian crossing sign is difficult to see when traveling westbound on Broadway. The sign is located behind a wide utility pole and under a large shade tree. According to the FHWA, pedestrian signs are important for indicating potential pedestrian presence to motorists and increasing rates of yielding.^v</p>

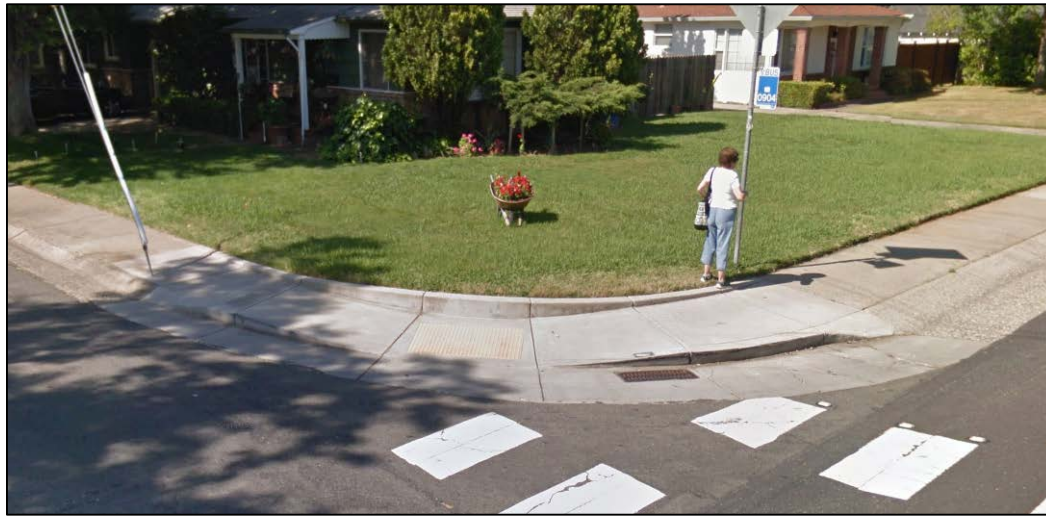
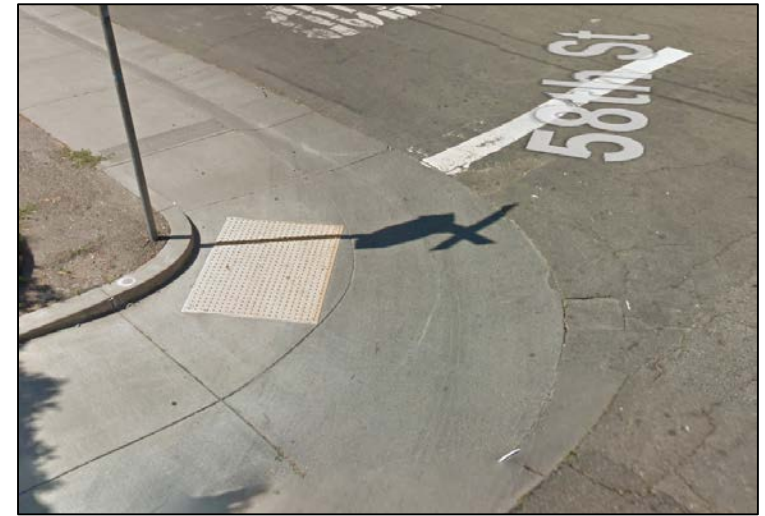
Visual

ID	Location	Recommendation	Justification
4	At all intersection on Broadway	<p>Similar to the intersection at 62nd Street, replace rolled curbs with vertical curbs at the following street corners:</p> <ul style="list-style-type: none"> • Broadway at 58th • Broadway at 60th • Broadway at 61st • Broadway at 63rd • Broadway at 64th • Broadway at Kroy • Broadway at 65th 	<p>Rolled curbs at intersections allow motorists making right turns to mount sidewalks. This fact was reinforced during the walk audit by participants who noted that near-collisions with pedestrians at corners are a common occurrence. At several corners along Broadway tire marks were present well within the pedestrian right of way. Vertical curbs at the corners of intersections, similar to those at 62nd Street, will improve pedestrian safety along Broadway.</p>

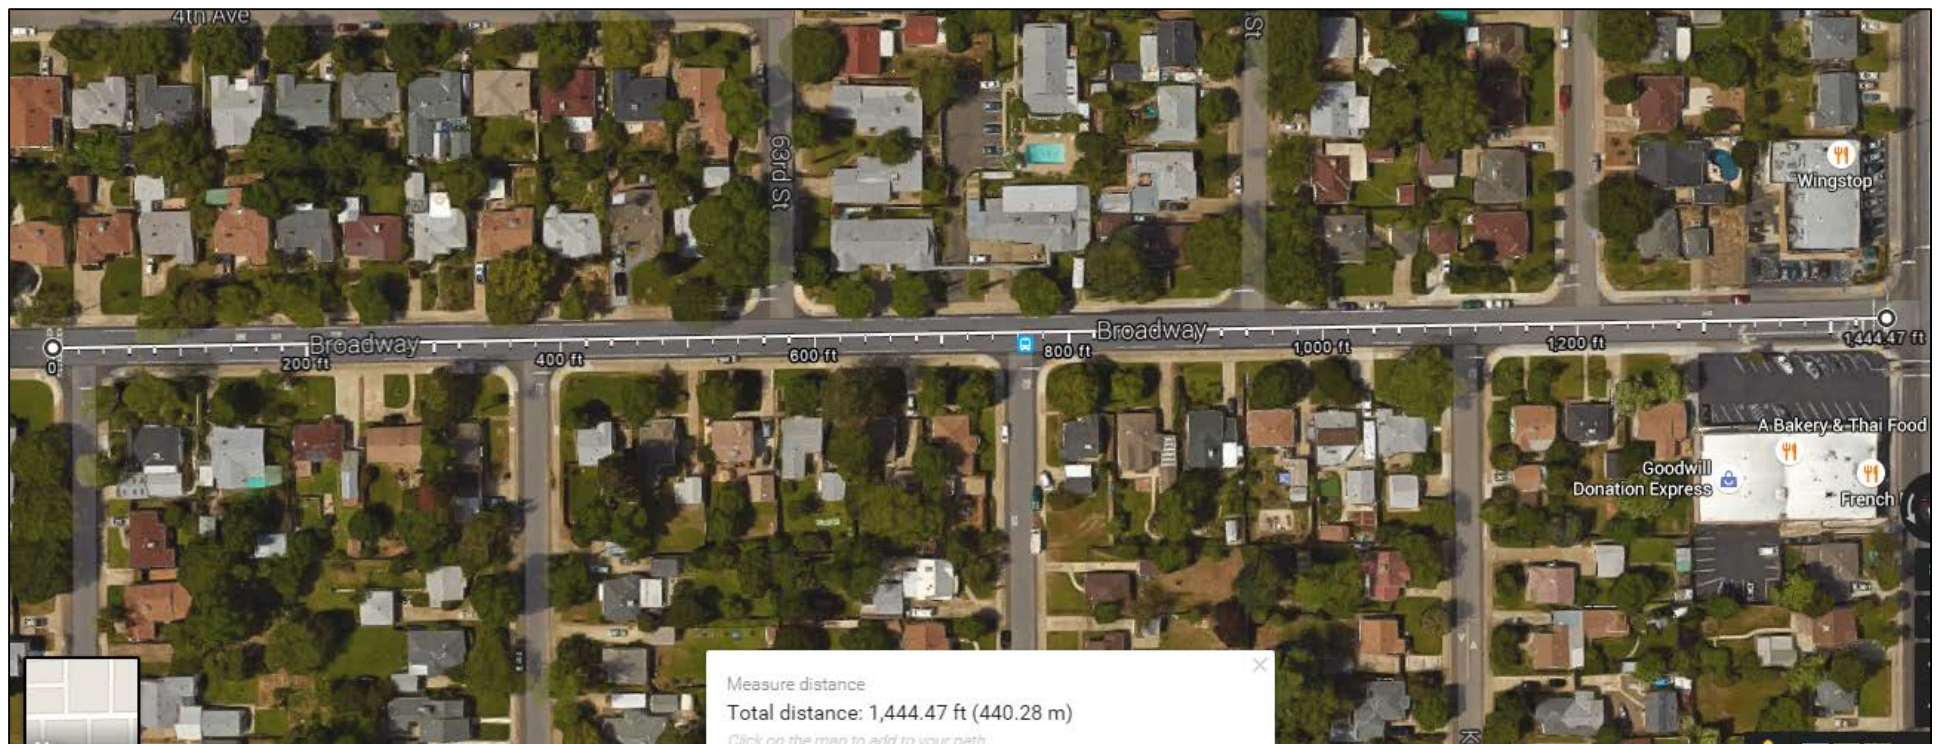
Visual

ID	Location	Recommendation	Justification
5	Between 62 nd Street and 65 th Street.	Install additional marked pedestrian crossings across Broadway	<p>The nearly 1450 ft. stretch of Broadway between 62nd Street and 65th Street has no marked crosswalks. The lack of crossings along this section of Broadway not only makes reaching bus stops and other destinations along Broadway more difficult, but makes Broadway a physical barrier that separates Tahoe Park. Additionally, studies show that rates of yielding for pedestrians at unmarked crosswalks can be as low as 5% in well-traveled areas.^{vi}</p> <p>Safe and frequent pedestrian crossings help create a more walkable community and as such should be installed along this stretch of Broadway.</p>

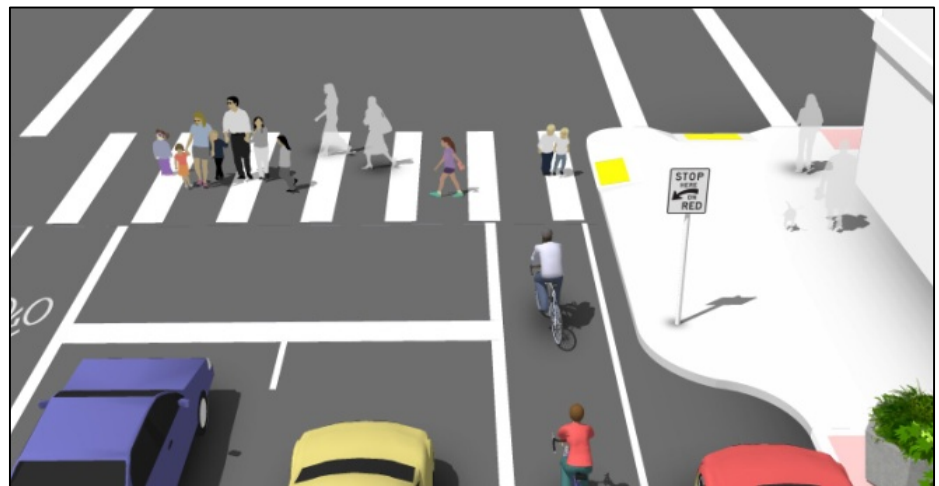
Visual

ID	Location	Recommendation	Justification
6	At all crosswalks on or across Broadway between 57 th Street and 65 th Street	<p>Restrict parking in advance of crosswalks</p> <p>Install advanced stop bars at the controlled intersection at 59th Street and at all future RRFB crosswalks</p>	<p>The National Association of City Transportation Officials guidelines recommend 20 to 25 feet of parking clearance around crosswalks to increase visibility of pedestrians both waiting to cross and already crossing.^{vii} According to the Federal Highway Safety Administration, a parking restriction of 20 ft. can significantly increase a motorist's line of sight.^{viii} Parking restrictions along Broadway can be accomplished via painted markings within the roadway, physical barriers such as flex-posts, or in combination with recommendation 8 by installing vertical red painted curbs at corners.</p> <p>According to the pedestrian and bicycle information center, an advance stop or yield line placed ahead of a crosswalk can greatly reduce the likelihood of a multiple-threat crash at unsignalized midblock crossings.^{ix} Advanced stop bars encourage motorists to stop well in advance of a crosswalk providing a buffer zone between the vehicle and pedestrian. According to one study, the use of a "sign alone reduced conflicts between drivers and pedestrians by 67%, and with the addition of an advanced stop or yield line, this type of conflict was reduced 90% compared to baseline levels."^x Advance stop bars should be installed throughout this corridor at all controlled crosswalks including any future RRFB crosswalks.</p>

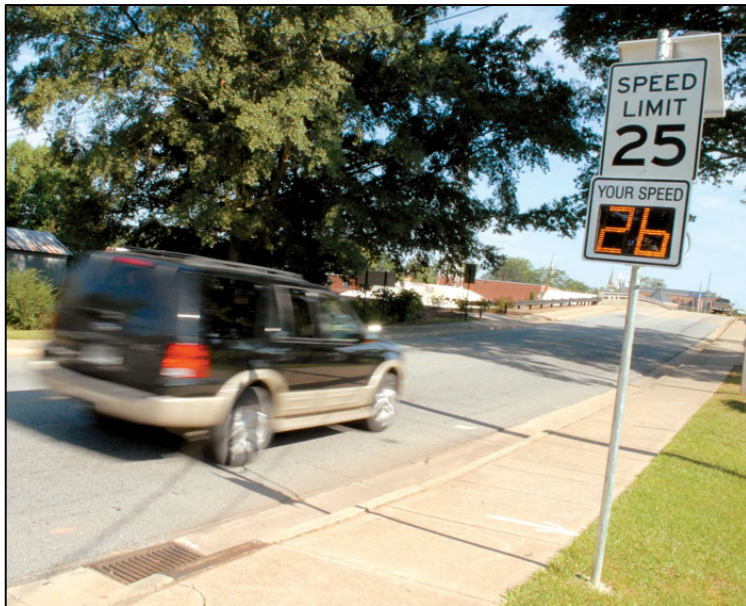
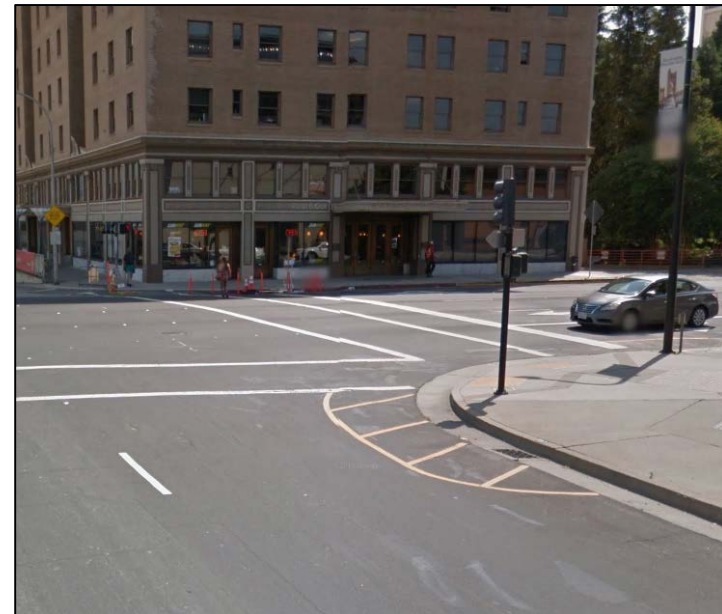
Visual

ID	Location	Recommendation	Justification
7	Between 62 nd Street and 65 th Street on Broadway, westbound	Install traffic countermeasures for reducing speeds.	<p>Between 62nd Street and 65th Street there are no traffic controls or traffic calming measures. Broadway has become an increasingly common route for cut-through traffic avoiding highway 50. The combination of these two factors seem to be contributing to high vehicle speeds along Broadway. WALKSacramento recommends installing any combination of the FHWA's Proven Safety Countermeasures for reducing speeds including on-road speed limit markings, speed feedback signs, curb extensions, and roadway markings that give the impression of narrowing lanes.^{xi}</p> <p>A promising option is to paint high visibility curb extensions onto Broadway that act as low-cost chokers. The benefit of doing so is that the painted extensions have the similar effect of narrowing the perceived roadway width for motorists and thus acting to slow traffic.^{xii} Additionally, the lack of paved or raised infrastructure allows for the continuous movement of emergency vehicles and bicycles. This is another improvement that can occur during a resurfacing effort.</p>

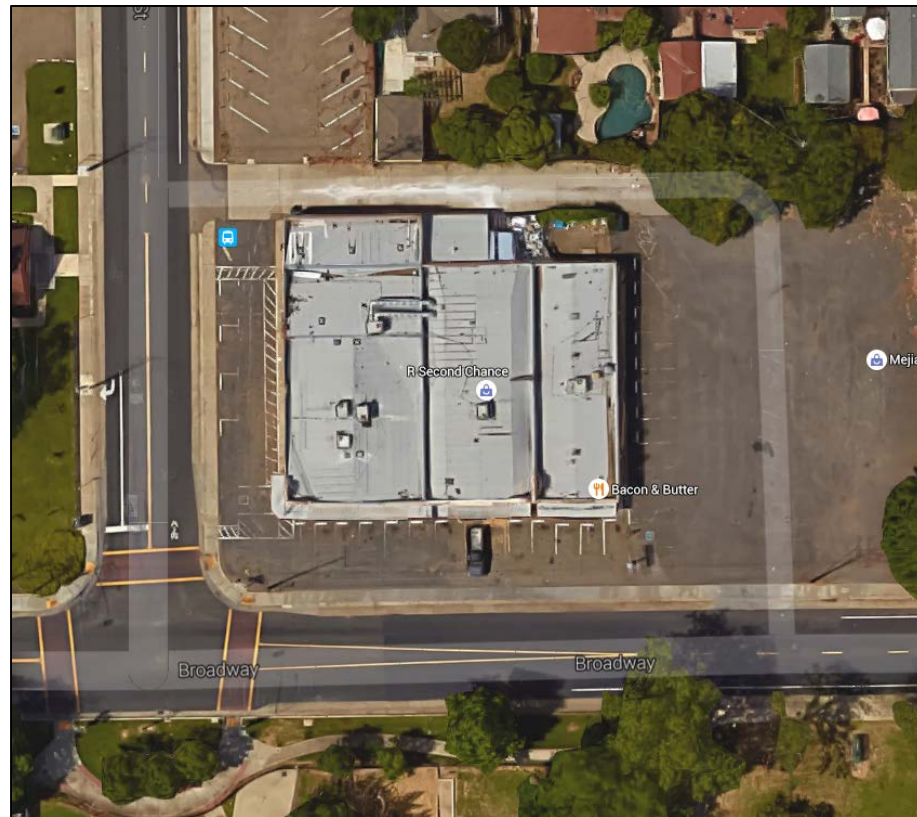
Visual

ID	Location	Recommendation	Justification
8	Building parking lot on Broadway between 59 th Street and 60 th Street.	Work with building owner to improve the waiting area along the east and south sides of the building.	<p>Patrons of Bacon and Butter have been observed waiting in the shade across the street by the elementary school, then crossing mid-block, often darting into oncoming traffic. Sporadic pedestrian behavior can put both pedestrians and motorists in danger.</p> <p>To help alleviate this issue, planter boxes for trees, seating, shade canopies, and other amenities should be installed along the east and south sides of the building to encourage patrons to wait by the restaurant. Additionally, streetscape activation through more outdoor seating, lighting, shade, and aesthetic treatments help to encourage pedestrian and bicycle travel and will contribute to a more main street feel.</p>

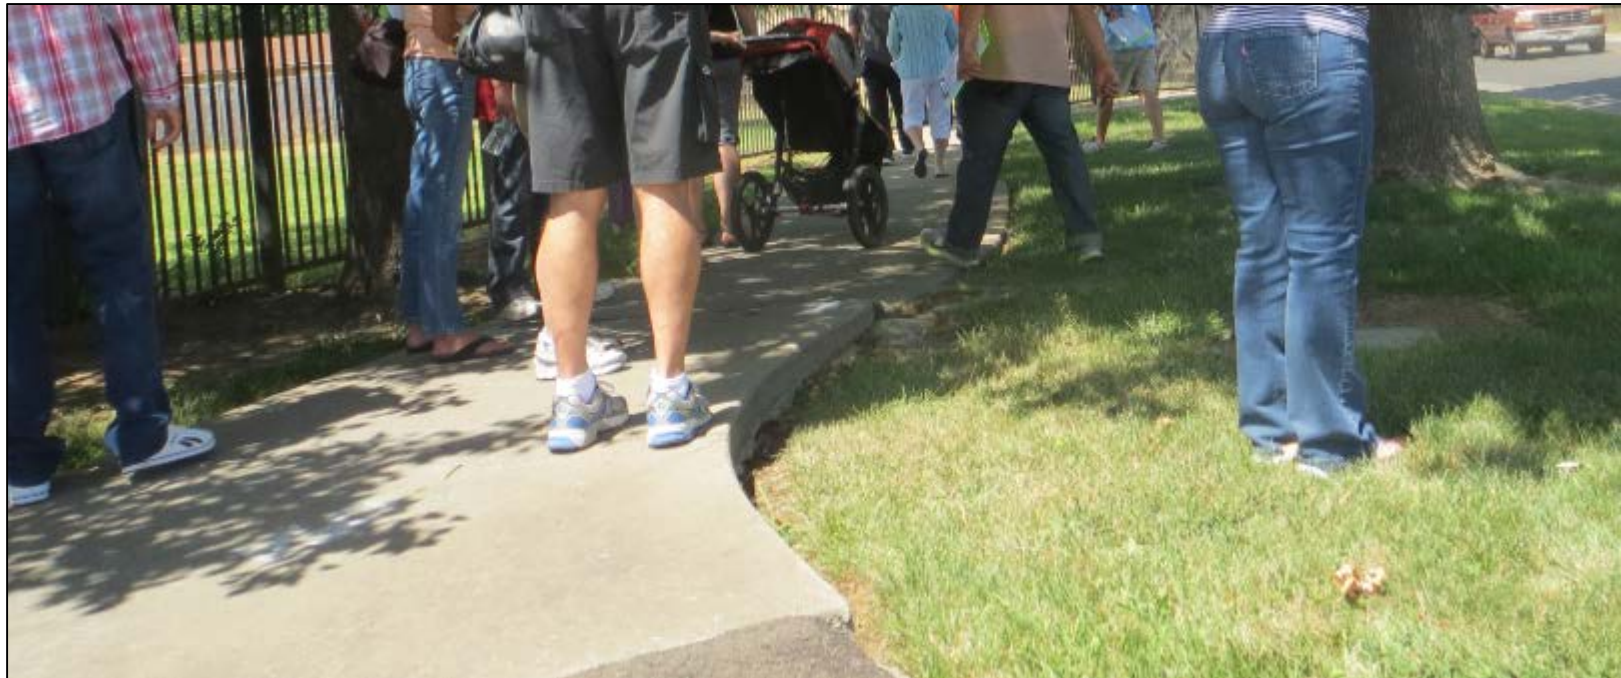
Visual

ID	Location	Recommendation	Justification
9	Meandering path adjacent to Tahoe School on Broadway between 58 th Street and 60 th Street	Fix the cracked sidewalk.	The sidewalk on the south side of Broadway at the 59 th Street intersection is cracked and creates a barrier for pedestrians, those in wheelchairs, small children on bikes, and those pushing strollers. Because sidewalk maintenance is the responsibility of adjacent landowners, the Elementary School should prioritize funds to improve the sidewalk along this stretch.

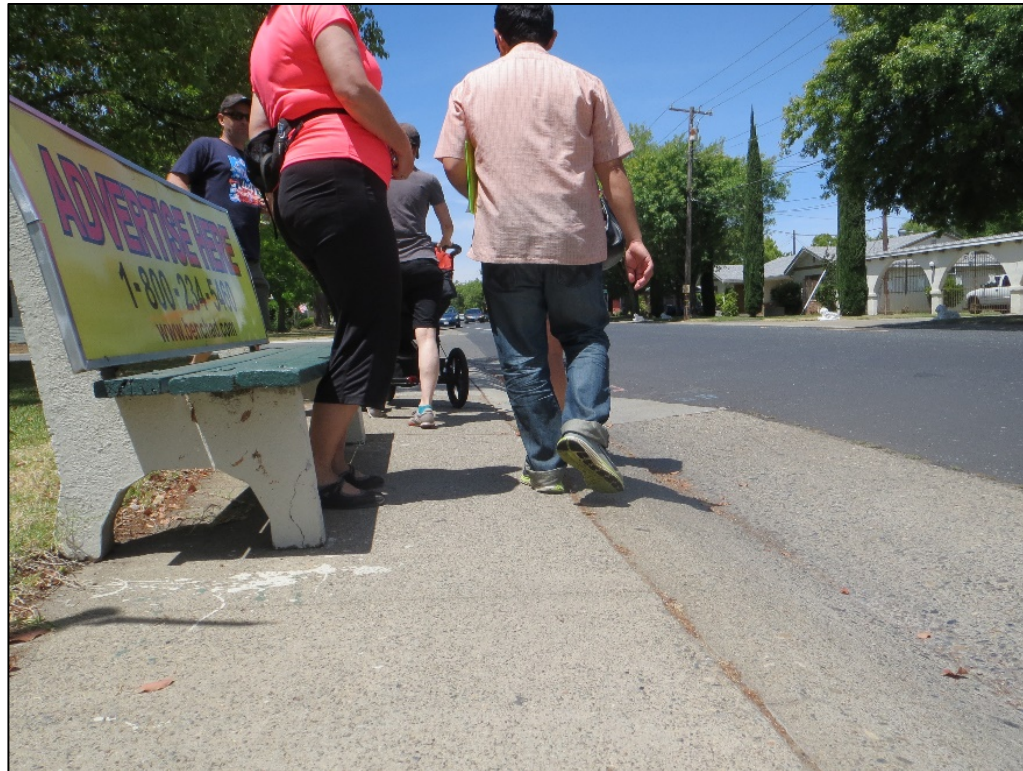
Visual

ID	Location	Recommendation	Justification
10	Along Broadway	Remove transit benches from the within the pedestrian right of way. Improve stops with additional lighting and protection.	<p>While seating at transit stops is an excellent improvement to the pedestrian environment, the benches along Broadway significantly encroach upon the pedestrian right of way. Because the benches are located within the sidewalk and not behind them, pedestrians, especially those with strollers or mobility devices, may be forced to walk out partially into the street to avoid the benches.</p> <p>Regional Transit should work with adjacent property owners and the City to increase the size of the transit stop to accommodate seating and pedestrian movement. Additional treatments such as pedestrian scale lighting and overhead shelters will further improve the safety and aesthetic quality at these transit stops. In the short term, the existing transit benches should be replaced with newer seating that discourages graffiti.</p>

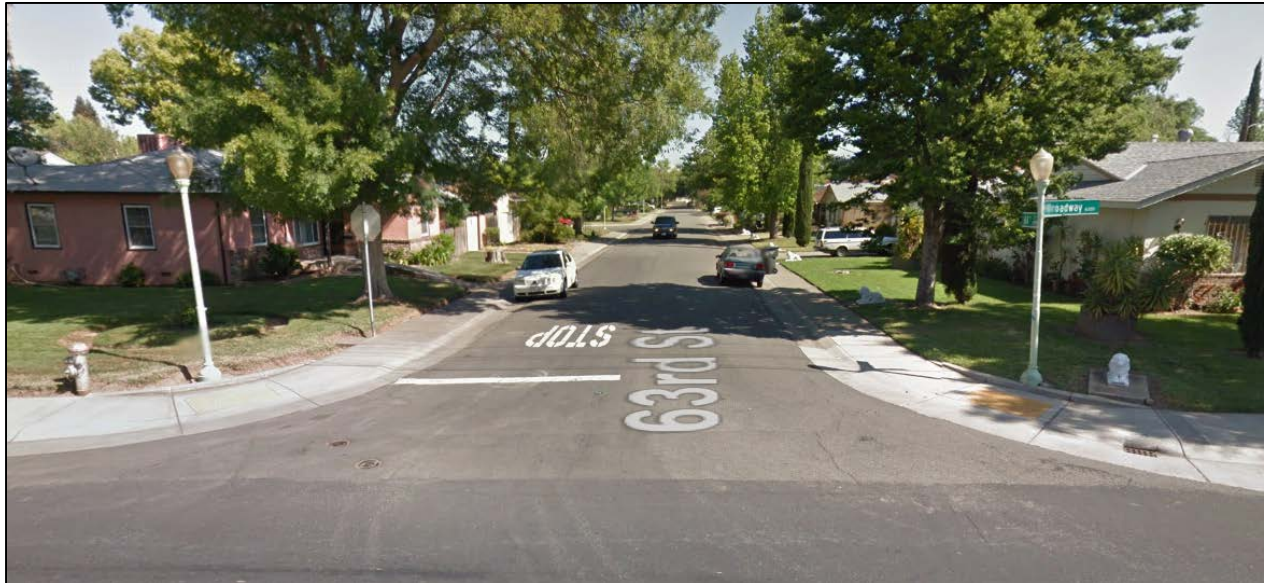
Visual

ID	Location	Recommendation	Justification
11	Along Broadway	Install additional pedestrian scale lighting similar to those at 63 rd Street.	Lighting at the pedestrian scale is not important for addressing safety, but can be attractively designed to improve the aesthetic along a corridor. Pedestrian scale lighting is closer to the ground and spaced closely together creating an even lighting of the sidewalk instead of alternating bright and dark spaces. Human-scale lighting addresses actual safety concerns, both personal and traffic related, as well as the perception of safety to encourage more walking and biking. Pedestrian-scale lighting is essential to creating an inviting, walkable, and attractive environment along Broadway. ^{xiii}

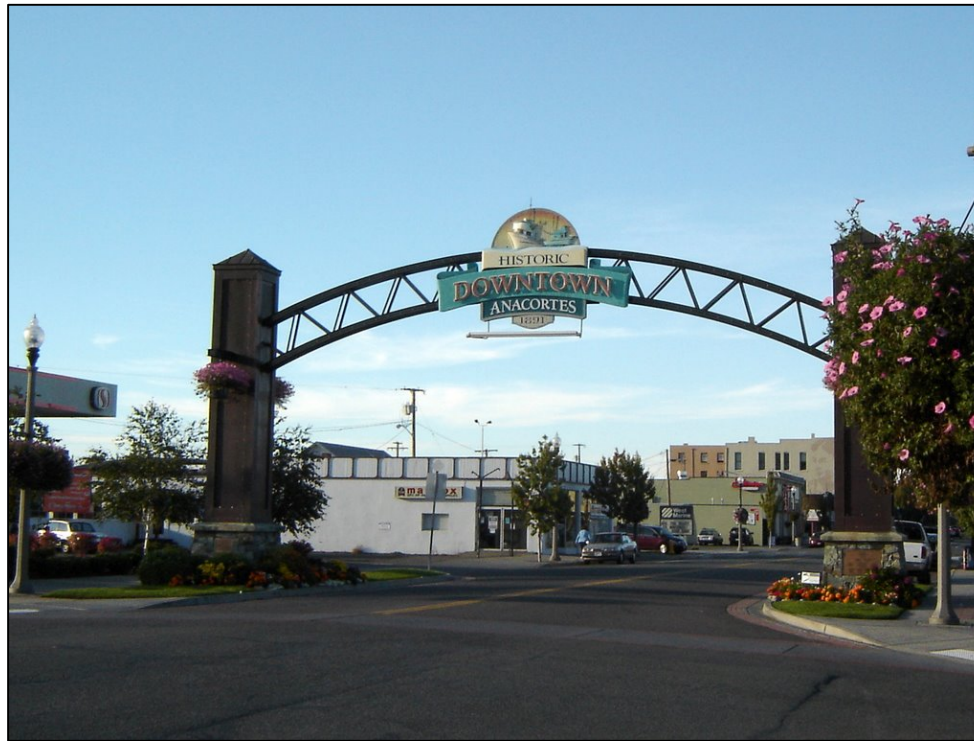
Visual

ID	Location	Recommendation	Justification
12	Along Broadway, especially at 57 th Street and 65 th Street.	Redesign Broadway to feel more like a main street. Install monument signage, seating, landscaping, and other treatments that encourage a "Downtown Tahoe Park" aesthetic.	Main street amenities such as monument signage, street furniture, art work, and signs will help give Broadway a more pedestrian oriented, downtown feel. Currently, a large number drivers use Broadway as an east-west cut-through street to avoid traffic on Highway 50. Participants on the walk audit made it clear that their priority for Broadway is not for it to be a cut-through street, but to be a main street destination that acts as "Downtown Tahoe Park." These aesthetic improvements will complement the traffic calming and safety improvements suggested above to further slow traffic and enhance the pedestrian experience.

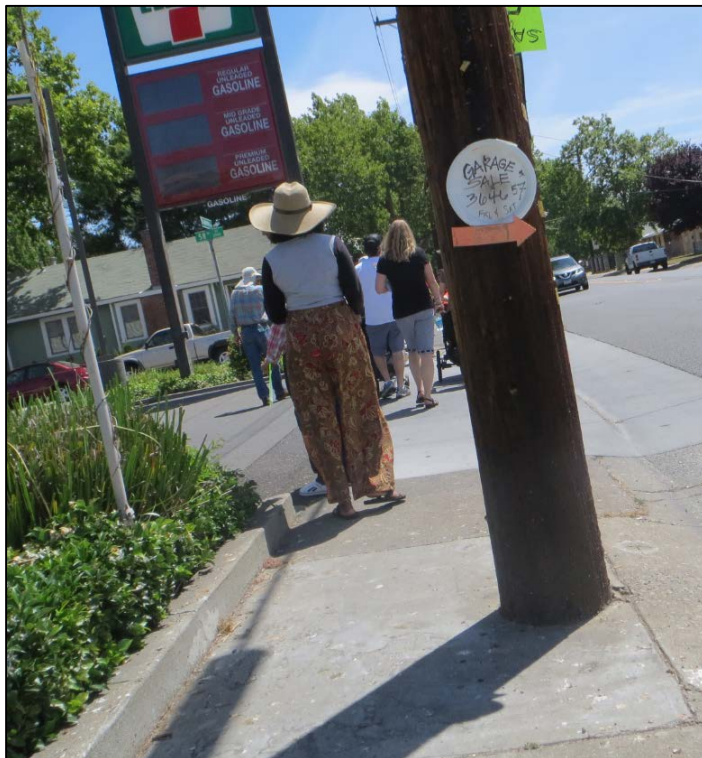
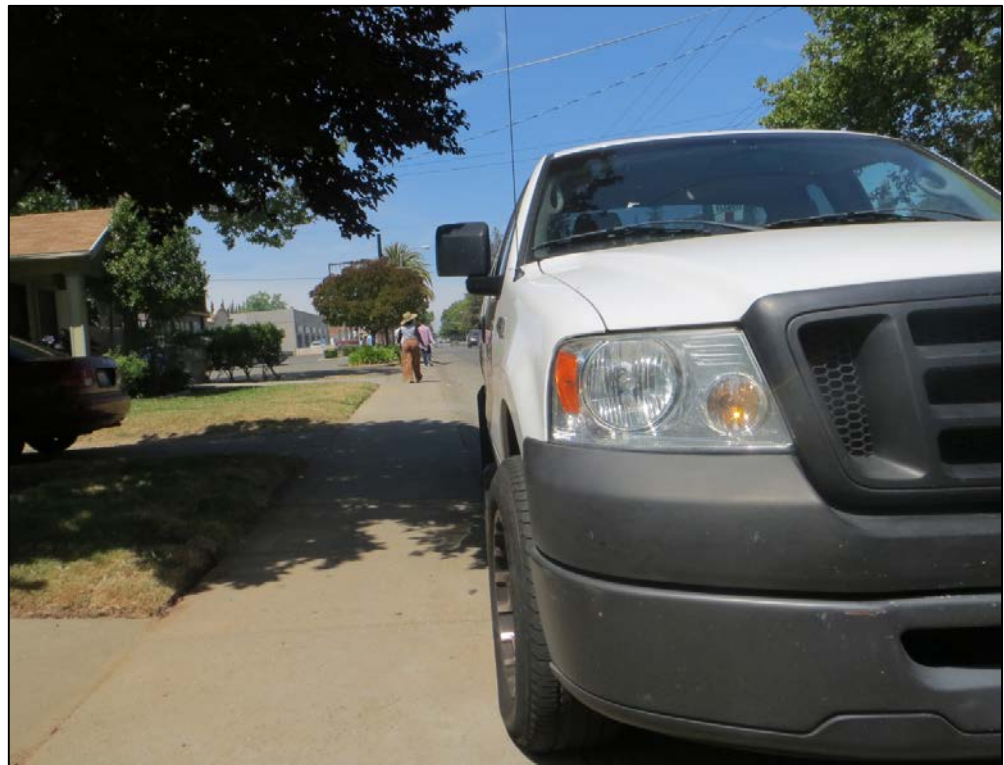
Visual

ID	Location	Recommendation	Justification
13	Along Broadway	Underground utility poles Convert all rolled curbs to vertical curbs	<p>There are four utility poles between 57th and 58th Street that obstruct the pedestrian right of way. Because undergrounding utility poles is an expensive process, this should be included as part of long term improvements along Broadway.</p> <p>The rolled curbs throughout the corridor allow for parked cars to mount the sidewalk and detract from the available walking space. Similarly, because a corridor wide retrofit can be expensive, this improvement should be considered within longer term improvement plans along Broadway.</p>
